**Flood Control Project Maintenance
Levee Inspections**

Fall 2015 Levee Maintenance Deficiency Summary Report

Sutter Maintenance Yard Hamilton Bend

Levee Inspection Report By Mile - Fall 2015

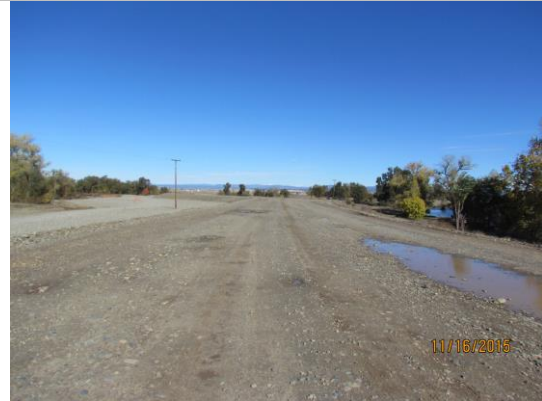
Photo 1 of 1 : FA_2015_ST0005_289_13_20151118_00013.jpg

LM Start	0.00	Rating **	A	Issue No.	13
LM End	1.21	Issue Type +	Ma	Location *	CR
Category	Earthen Levee			GPS Latitude/Longitude	
				Start	End
Item	Crown Surface / Depressions / Rutting			39.439712 °	39.456765 °
				-121.641457 °	-121.639258 °
DWR ID	DWR_ST0005_01_f_2015_13				
Action/Comments					
Add appropriate material and re-grade the levee to bring the crown above the design elevation. Inspector Comments: The SBFCA levee project is still in construction phase so I was unable to inspect the levee from levee mile 0.00 to 1.21.

View of the crown roadway under construction.

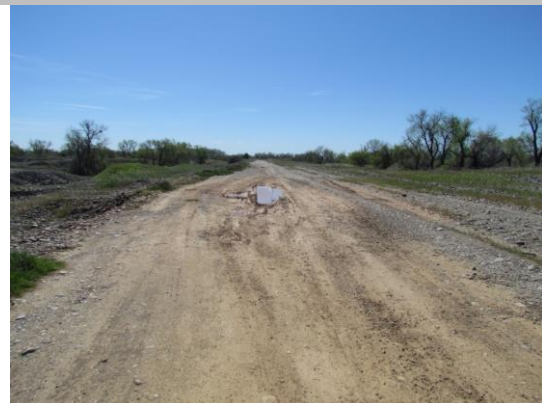
Photo 1 of 1 : FA_2015_ST0005_289_12_20151109_00004.jpg

This photo was taken from the levee crown facing north looking at crown surface depressions caused by vehicle traffic. Spring 2014.

LM Start	0.37	Rating **	M	Issue No.	12
LM End	0.37	Issue Type +	Ma	Location *	CR
Category	Earthen Levee			GPS Latitude/Longitude	
				Start	End
Item	Crown Surface / Depressions / Rutting			39.445008 °	39.445008 °
				-121.641811 °	-121.641812 °
DWR ID	DWR_ST0005_01_s_2014_12				
Action/Comments					
Repair depressions or ruts in the crown or slope.

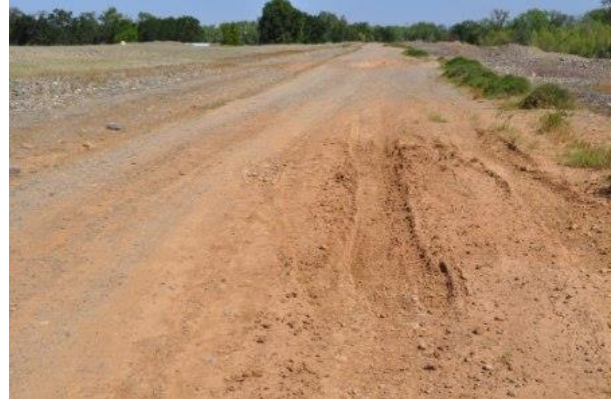
Photo 1 of 1 : FA_2015_ST0005_289_2_20151109_00001.jpg

Deep rut in crown. Repair prior to flood season.

LM Start	0.40	Rating **	M	Issue No.	2
LM End	0.40	Issue Type +	Ma	Location *	CR
Category	Earthen Levee			GPS Latitude/Longitude	
				Start	End
Item	Crown Surface / Depressions / Rutting			39.445420 °	39.445430 °
				-121.641809 °	-121.641802 °
DWR ID	DWR_ST0005_01_s_2015_2				
Action/Comments					
Add appropriate material and re-grade the levee to bring the crown above the design elevation.

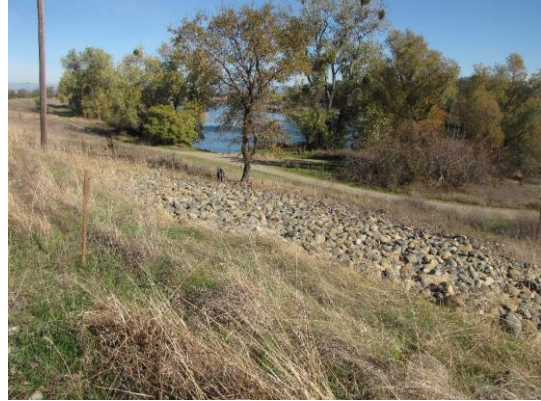
Photo 1 of 3 : UCIP_FA_2015_0853.jpg

Inspector Comments: FS_ID:13237
 DS_ID:17047
 EP_NO: 927
 FS_HLM: 0.796
 Repair Type: Non-Urgent
 Crossing Status: Found
 UCIP Comments: low spot on WS slope; sink hole or section dug-unable to tell; hole on levee toe. This crossing was listed in the USACE Periodic Inspection as ID# USACE_CESPK_HAM1_2010_a_0029 no issues reported.5/14/2013 SBFCA project recommends removal.5/14/2013 Same as last inspection.
 FIELD_STRUCT_DESC: Abandoned 10-inch steel pipe through the levee 10.4 feet below the crown. (Permit No. 927)
 FS Date: 05/14/2013

View of waterward side with rip rap along slope.

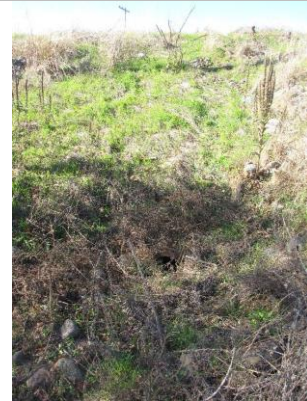
Photo 2 of 3 : UCIP_FA_2015_0854.jpg

Depression/Settlement at pipe exposure on waterward side.

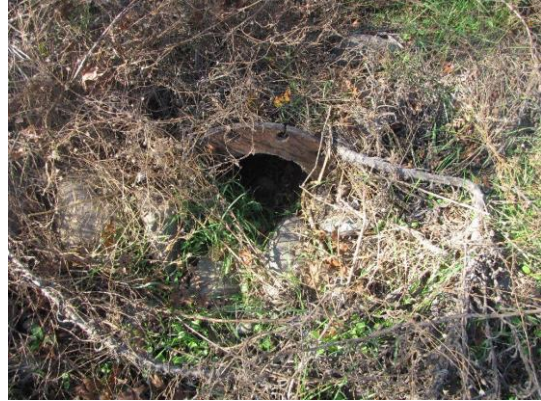
Photo 3 of 3 : UCIP_FA_2015_0855.jpg

Close up of pipe located on waterward side.

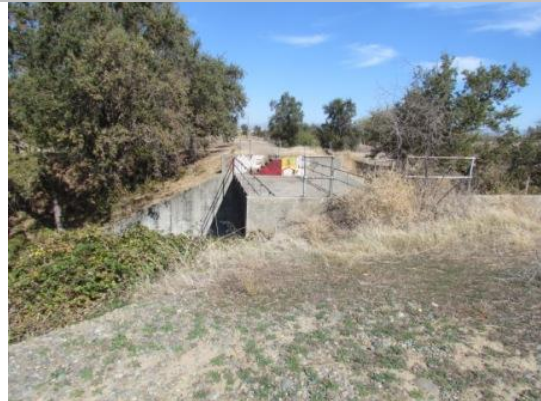
Photo 1 of 1 : FA_2015_ST0005_289_28_20151109_00008.jpg

LM Start	1.05	Rating **	M	Issue No.	28
LM End	1.05	Issue Type +	En	Location *	CR
Category	Earthen Levee			GPS Latitude/Longitude	
				Start	End
Item	Encroachments			39.454485 °	39.454485 °
				-121.640309 °	-121.640309 °
DWR ID	DWR_ST0005_01_f_2013_28				
Action/Comments					
Building Inspector Comments: Abandoned inlet structure.

This photo was taken facing north looking down the levee crown at an old inlet structure. Fall 2013.

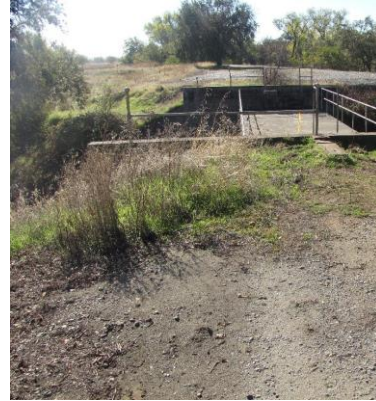
Photo 1 of 3 : UCIP_FA_2015_0859.jpg

LM Start	1.05	Rating **	M	Issue No.	30
LM End	1.05	Issue Type +	En	Location *	CR
Category	Supplemental			GPS Latitude/Longitude	
				Start	End
Item	DWR UCIP Field Study			39.454557 °	39.454557 °
				-121.640274 °	-121.640274 °
DWR ID					
Action/Comments					
Inspector Comments: FS_ID:13241 DS_ID:17046 EP_NO: N/A FS_HLM: 1.05 Repair Type: Non-Urgent Crossing Status: Found UCIP Comments: abandoned WS gates closed; handles broken; Structure needs to be properly abandoned. This crossing was listed in the USACE Periodic Inspection as ID# USACE_CESPK_HAM1_2010_a_0043 no issues reported.5/14/2013 Same as last inspection. FIELD_STRUCT_DESC: Abandoned Sutter Butte Canal head gate structure, Six 6 by 8 foot concrete culvert 35.8 feet below the crown. Stems on gates are removed and gates are in a closed position. This entry matches the Drainage or Irrigation Structure referenced in O&M manual (Historic Station 47+00). (USACE O&M Manual, 1957) FS Date: 05/14/2013

View of concrete structure, Photo 2 of 2.

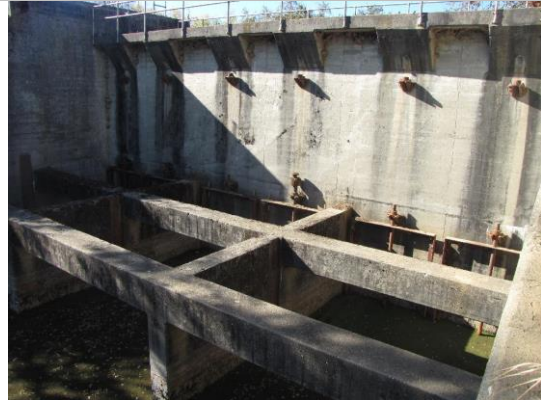
Photo 2 of 3 : UCIP_FA_2015_0860.jpg

View of waterward side, slide gates rods and handles missing.

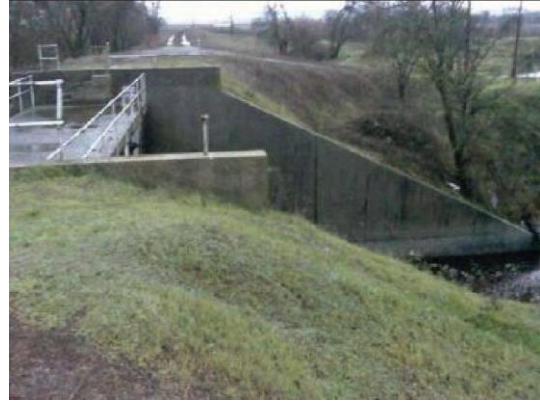
Photo 3 of 3 : UCIP_FA_2015_0861.jpg

View of concrete structure, Photo 1 of 2.

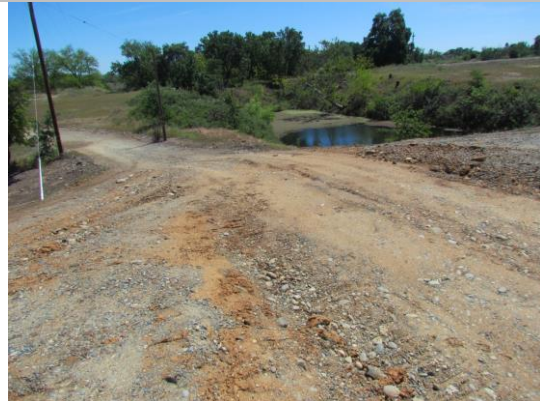
Photo 1 of 2 : FA_2015_ST0005_289_18_20151109_00005.jpg

View of the depression on the crown facing the waterside of the levee.

LM Start	1.08	Rating **	U	Issue No.	18
LM End	1.08	Issue Type +	Ma	Location *	CR
Category	Earthen Levee			GPS Latitude/Longitude	
				Start	End
Item	Crown Surface / Depressions / Rutting			39.454935 °	39.454935 °
				-121.640097 °	-121.640097 °
DWR ID	DWR_ST0005_01_s_2015_18				
Action/Comments					
Repair depressions or ruts in the crown or slope.

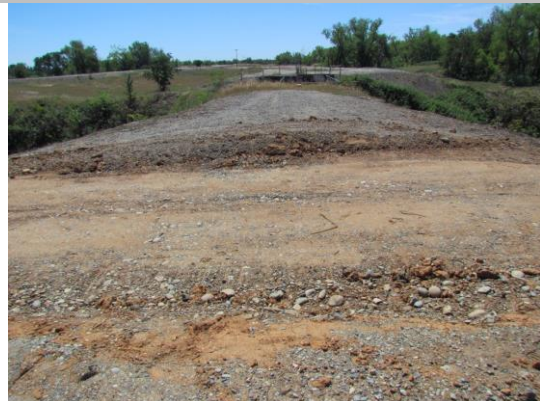
Photo 2 of 2 : FA_2015_ST0005_289_18_20151109_00006.jpg

View of the depression on the crown facing downstream.

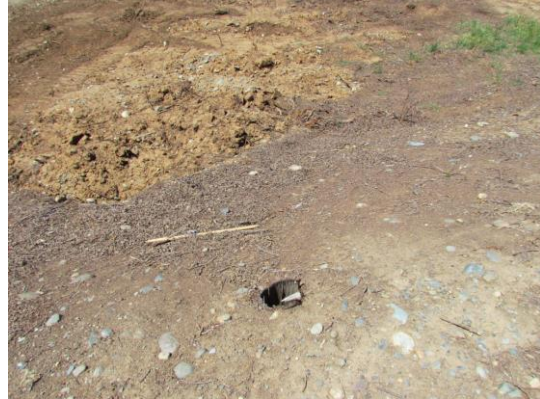
Photo 1 of 1 : FA_2015_ST0005_289_19_20151109_00007.jpg

LM Start	1.08	Rating **	U	Issue No.	19
LM End	1.08	Issue Type +	En	Location *	LS
Category	Earthen Levee			GPS Latitude/Longitude	
				Start	End
Item	Encroachments			39.454935 °	39.454935 °
				-121.640097 °	-121.640097 °
DWR ID	DWR_ST0005_01_s _ 2015_19				
Action/Comments					
Pole					
Inspector Comments: Decayed pole has left a deep hole in the levee.

View of the pole on the landside of the levee facing upstream. The pole is hollow and appears to be very deep.

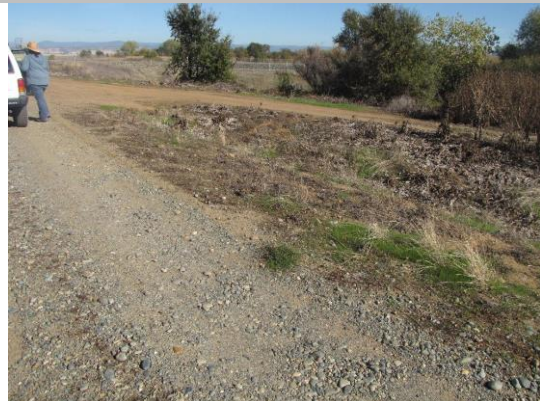
Photo 1 of 3 : UCIP_FA_2015_0856.jpg

LM Start	1.18	Rating **	M	Issue No.	31
LM End	1.18	Issue Type +	En	Location *	LS
Category	Supplemental			GPS Latitude/Longitude	
				Start	End
Item	DWR UCIP Field Study			39.456287 °	39.456287 °
				-121.639530 °	-121.639530 °
DWR ID					
Action/Comments					
Inspector Comments: FS_ID:13238 DS_ID:17045 EP_NO: N/A FS_HLM: 1.17 Repair Type: Non-Urgent Crossing Status: Indicator Found UCIP Comments: Abandoned structure: Structure is non-operational, slide gate is completely buried; top of slide gate barely visible from levee;5/14/2013 Same as last inspection. FIELD_STRUCT_DESC: Abandoned 24-inch pipe through the levee 16.5 feet below the crown. Slide gate in CM riser on the waterward slope. No features of structure were found with the exception of slide gate frame. FS Date: 05/14/2013

View of waterward side looking upstream at crossing.

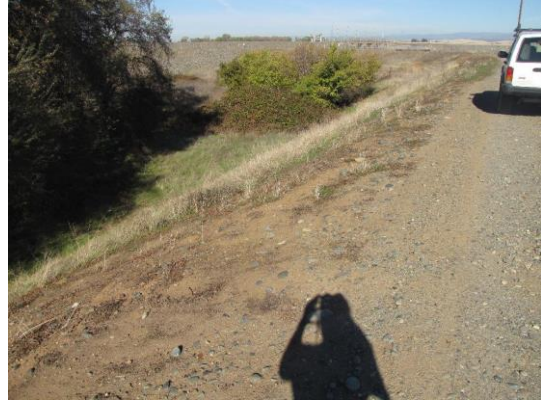
Photo 2 of 3 : UCIP_FA_2015_0857.jpg

Inspector Comments: FS_ID:13238
 DS_ID:17045
 EP_NO: N/A
 FS_HLM: 1.17
 Repair Type: Non-Urgent
 Crossing Status: Indicator Found
 UCIP Comments: Abandoned structure: Structure is non-operational, slide gate is completely buried; top of slide gate barely visible from levee; 5/14/2013 Same as last inspection.
 FIELD_STRUCT_DESC: Abandoned 24-inch pipe through the levee 16.5 feet below the crown. Slide gate in CM riser on the waterward slope. No features of structure were found with the exception of slide gate frame.
 FS Date: 05/14/2013

View of landward side looking upstream at crossing.

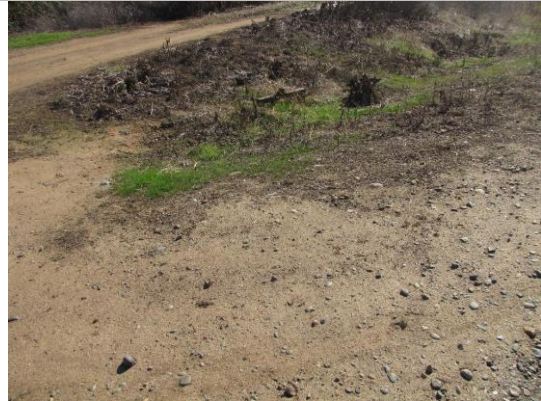
Photo 3 of 3 : UCIP_FA_2015_0858.jpg

View of slide gate framing at low point in between levee crown and secondary dirt access road.

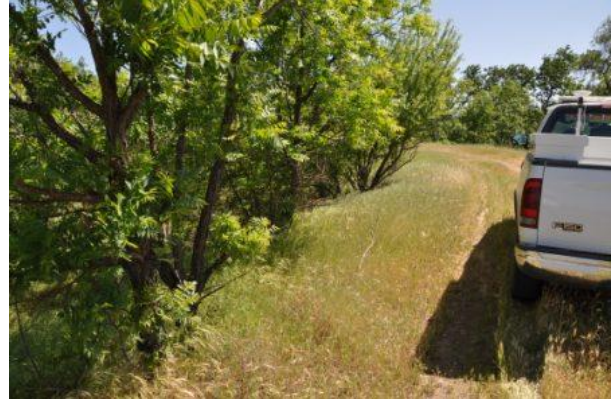
Photo 1 of 1 : FA_2015_ST0005_289_4_20151109_00002.jpg

L/S trees.

LM Start	1.48	Rating **	M	Issue No.	4
LM End	3.26	Issue Type +	Ma	Location *	LS
Category	Earthen Levee			GPS Latitude/Longitude	
				Start	End
Item	Trim / Thin Trees			39.458060 °	39.470433 °
				-121.636332 °	-121.609200 °
DWR ID	DWR_ST0005_01_s_2013_4				
Action/Comments					
Trim and thin trees to allow visibility of the ground and room to flood fight.

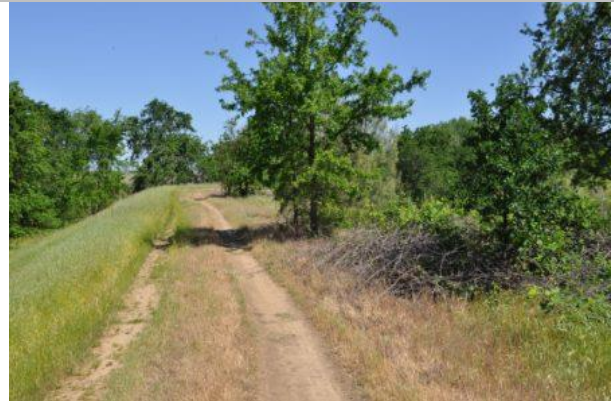
Photo 1 of 1 : FA_2015_ST0005_289_5_20151109_00003.jpg

W/S trees.

LM Start	1.51	Rating **	M	Issue No.	5
LM End	1.69	Issue Type +	Ma	Location *	WS
Category	Earthen Levee			GPS Latitude/Longitude	
				Start	End
Item	Trim / Thin Trees			39.458255 °	39.459451 °
				-121.635808 °	-121.633670 °
DWR ID	DWR_ST0005_01_s_2013_5				
Action/Comments					
Trim and thin trees to allow visibility of the ground and room to flood fight.

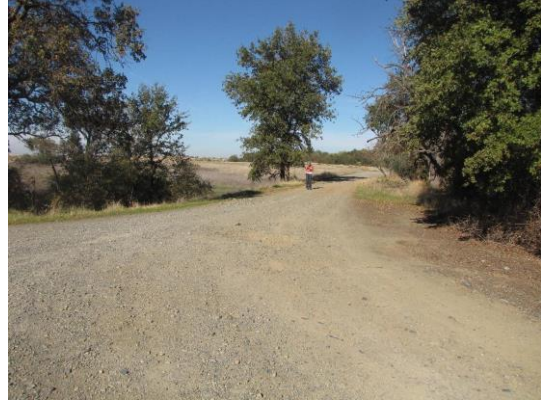
Photo 1 of 3 : UCIP_FA_2015_0643.jpg

LM Start	3.25	Rating **	M	Issue No.	32
LM End	3.25	Issue Type +	En	Location *	WS
Category	Supplemental			GPS Latitude/Longitude	
				Start	End
Item	DWR UCIP Field Study			39.470269 °	39.470269 °
				-121.609229 °	-121.609229 °
DWR ID					
Action/Comments					
Inspector Comments: FS_ID:13243 DS_ID:17056 EP_NO: N/A FS_HLM: 3.171 Repair Type: Non-Urgent Crossing Status: Indicator Found UCIP Comments: Abandoned Structure: WS- reminince of gates and concrete standpipe; LS-reminince of concrete headwall and pump station.5/14/2013 Same as last inspection. FIELD_STRUCT_DESC: Abandoned western canal head gate inlet structure. Two (2) of 2 culverts, 8 by 8-foot concrete culverts through the levee 25.0 feet below the crown. Three slide gates on the waterward end. Concrete stairs on the waterward slope. Concrete headwall at both toes. This entry matches the Drainage or Irrigation Structure referenced in O&M manual (Historic Station 170+00). (USACE O&M Manual, 1957) FS Date: 05/14/2013

View of levee crown looking upstream at crossing.

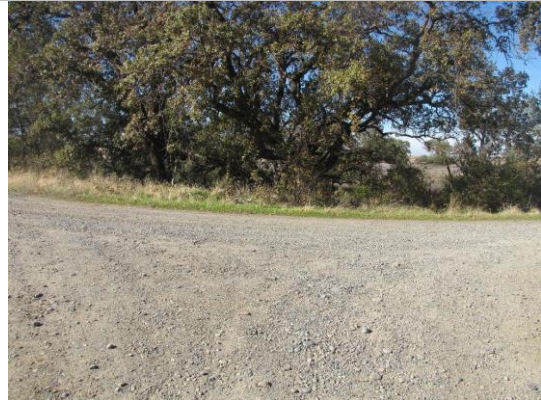
Photo 2 of 3 : UCIP_FA_2015_0644.jpg

View of levee crown at a right bend.

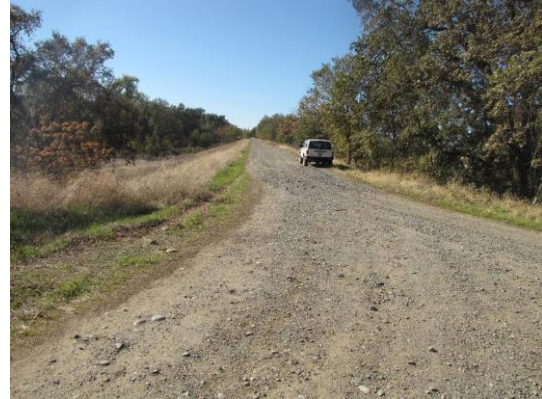
Photo 3 of 3 : UCIP_FA_2015_0645.jpg

View of levee crown looking downstream.

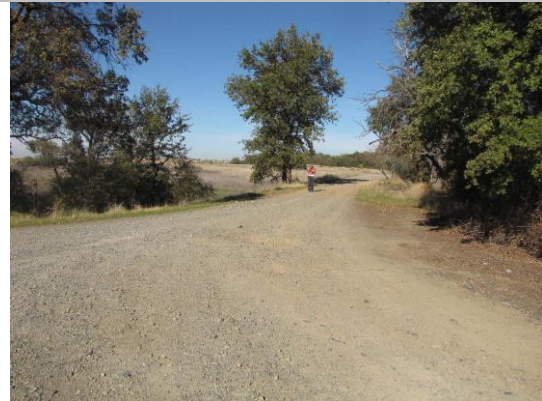
Photo 1 of 3 : UCIP_FA_2015_0862.jpg

LM Start	3.25	Rating **	M	Issue No.	33
LM End	3.25	Issue Type +	En	Location *	WS
Category	Supplemental			GPS Latitude/Longitude	
				Start	End
Item	DWR UCIP Field Study			39.470269 °	39.470269 °
				-121.609229 °	-121.609229 °
DWR ID					
Action/Comments					
Inspector Comments: FS_ID:13242					
DS_ID:17044					
EP_NO: N/A					
FS_HLM: 3.171					
Repair Type: Non-Urgent					
Crossing Status: Indicator Found					
UCIP Comments: Abandoned Structure: WS- reminince of gates and concrete standpipe; LS-reminince of concrete headwall and pump station.5/14/2013 Same as last inpection.					
FIELD_STRUCT_DESC: Abandoned western canal head gate inlet structure. One (1) of 2 culverts, 8 by 8-foot concrete culverts through the levee 25.0 feet below the crown. Three slide gates on the waterward end. Concrete stairs on the waterward slope. Concrete headwall at both toes. This entry matches the Drainage or Irrigation Structure referenced in O&M manual (Historic Station 170+00). (USACE O&M Manual, 1957)

View of levee looking upstream.

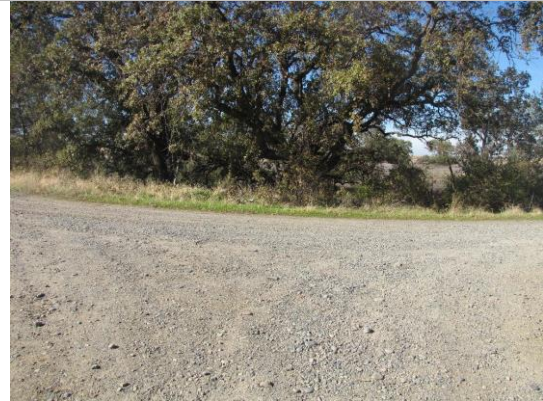
Photo 2 of 3 : UCIP_FA_2015_0863.jpg

LM Start	3.25	Rating **	M	Issue No.	33 (cont)
LM End	3.25	Issue Type +	En	Location *	WS
Category	Supplemental			GPS Latitude/Longitude	
				Start	End
Item	DWR UCIP Field Study			39.470269 °	39.470269 °
				-121.609229 °	-121.609229 °
DWR ID					
Action/Comments					
Inspector Comments: FS_ID:13242 DS_ID:17044 EP_NO: N/A FS_HLM: 3.171 Repair Type: Non-Urgent Crossing Status: Indicator Found UCIP Comments: Abandoned Structure: WS- reminince of gates and concrete standpipe; LS-reminince of concrete headwall and pump station.5/14/2013 Same as last inpection. FIELD_STRUCT_DESC: Abandoned western canal head gate inlet structure. One (1) of 2 culverts, 8 by 8-foot concrete culverts through the levee 25.0 feet below the crown. Three slide gates on the waterward end. Concrete stairs on the waterward slope. Concrete headwall at both toes. This entry matches the Drainage or Irrigation Structure referenced in O&M manual (Historic Station 170+00). (USACE O&M Manual, 1957) FS Date: 05/14/2013

View of levee crown at right bend.

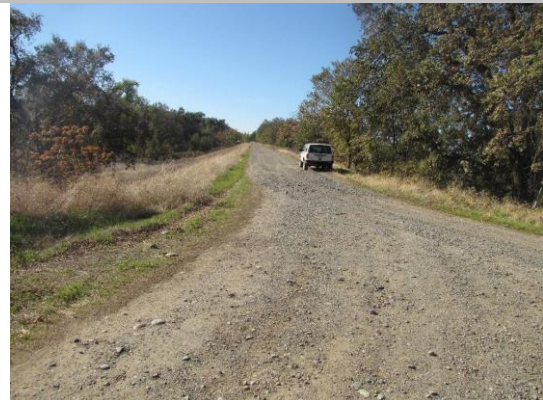
Photo 3 of 3 : UCIP_FA_2015_0864.jpg

View of levee crown looking downstream.
